**TEST & EVALUATION REPORT**  
Screening Evaluation of Shingle Rejuvenator

August 15, 2018

**Report For:** Bio-Based Spray Systems, LLC, Greener Shingle Solutions

**Project No.:** BBSS 01-02-01

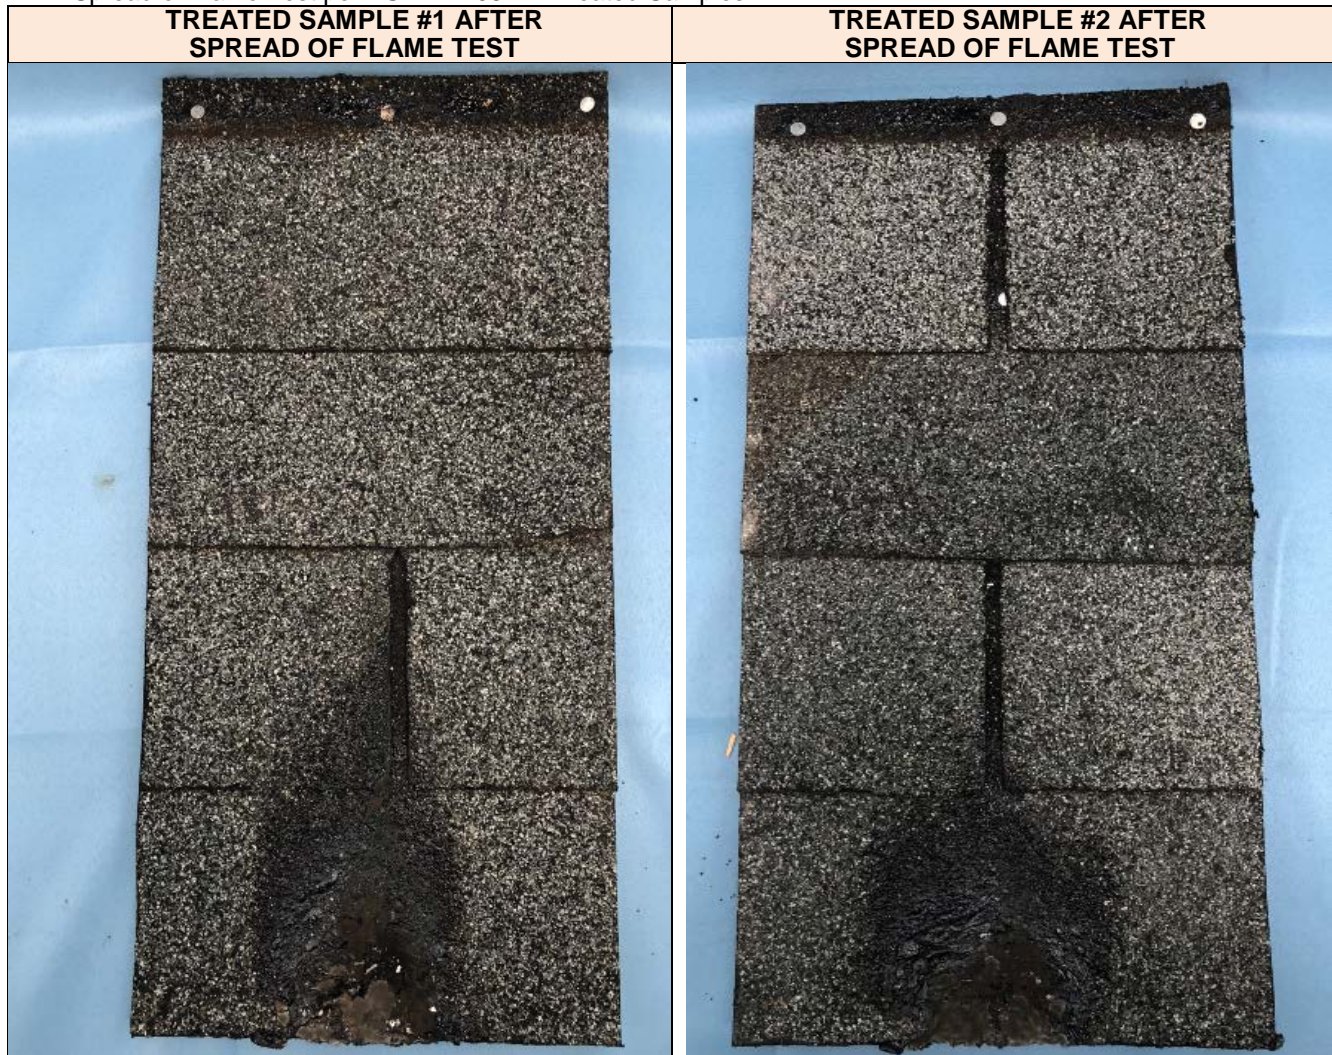
## A1. Spread of Flame Test per ASTM E108M – Treated Samples

Spread of flame covered less surface area (a distinct benefit). This is worthy of further investigation.

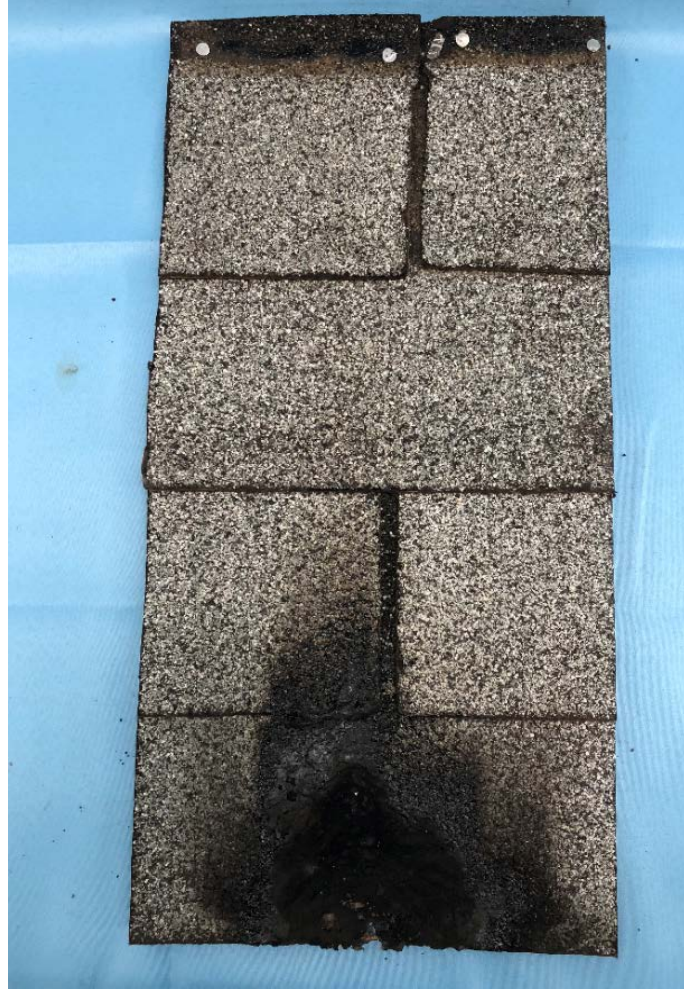
**A2. Spread of Flame Test per ASTM E108M – Untreated Samples**

- UNTREATED SAMPLE #3 AFTER SPREAD OF FLAME TEST	-

The control exhibited significantly more spread and damage than the treated shingles.
